JANUARY 1983 THE NAVAL AVIATION SAFETY REVIEW

THEORETICAL ASPECTS OF AIRCRAFT FLIGHT THROUGH MICROBURST CONDITIONS

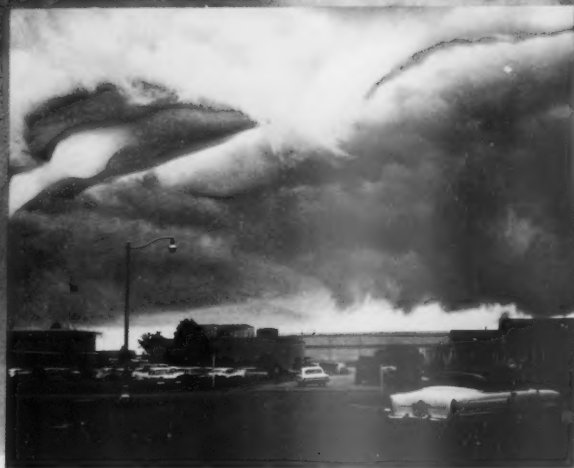
Synopsis. Under certain conditions, a negative angle of attack can develop during aircraft flight through microburst conditions. This can generate a downward lift vector that results when a high-pressure area has developed above the airfoil and a low-pressure area has developed below. This reversal is the direct opposite of a positive-lift-producing wing. (Navy tactical aircraft could conceivably find their AOA gauge pegged out on the low end of the scale.) Hence, the aircraft can be "drawn into the ground" unless it is immediately and sufficiently rotated to produce a positive angle of attack with subsequent generation of positive lift. This pitch attitude may exceed the maximum pitch attitude normally recommended during a missed approach or take-off. Always ensure the application of **maximum thrust** simultaneously with aircraft rotation.
